Service Memo – Handle Set Shaft Adjustment

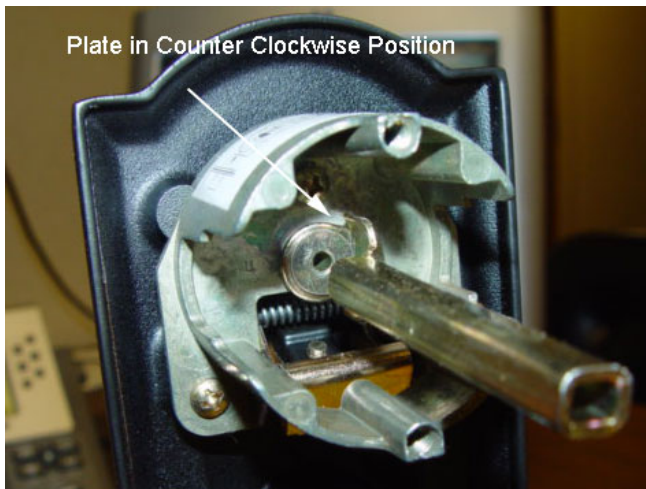
Figure 1

Problem Solution: The shaft that extends from the exterior thumb latch in to the door has a flat plate on it. When depressing the thumb latch the orientation of the plate to the thumb latch will determine if the shaft rotates clockwise (see figure one) or counter clockwise (see figure two).

To change this, just remove the exterior handle and rotate the shaft 180 degrees. Figure 3 is a snippet from the Schlage instructions covering this part of the installation.

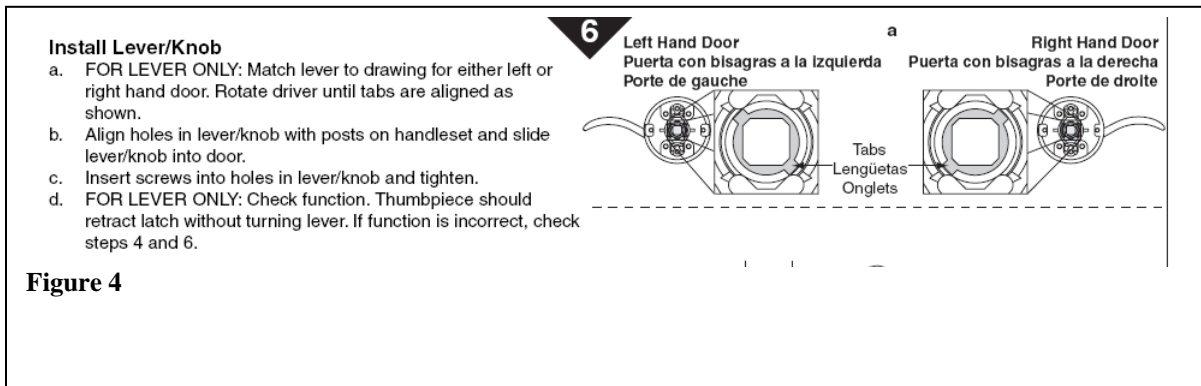
instructions. If either of these items are not in the correct position the handle and/or interior lever will not work as designed.

In additional to the handle set shaft orientation, the cams for the interior levers need to be set in the correct position. See Figure 4 for these
